PIPELINE INVESTIGATION REPORT

P01H0004

CRUDE OIL PIPELINE RUPTURE

ENBRIDGE PIPELINES INC.

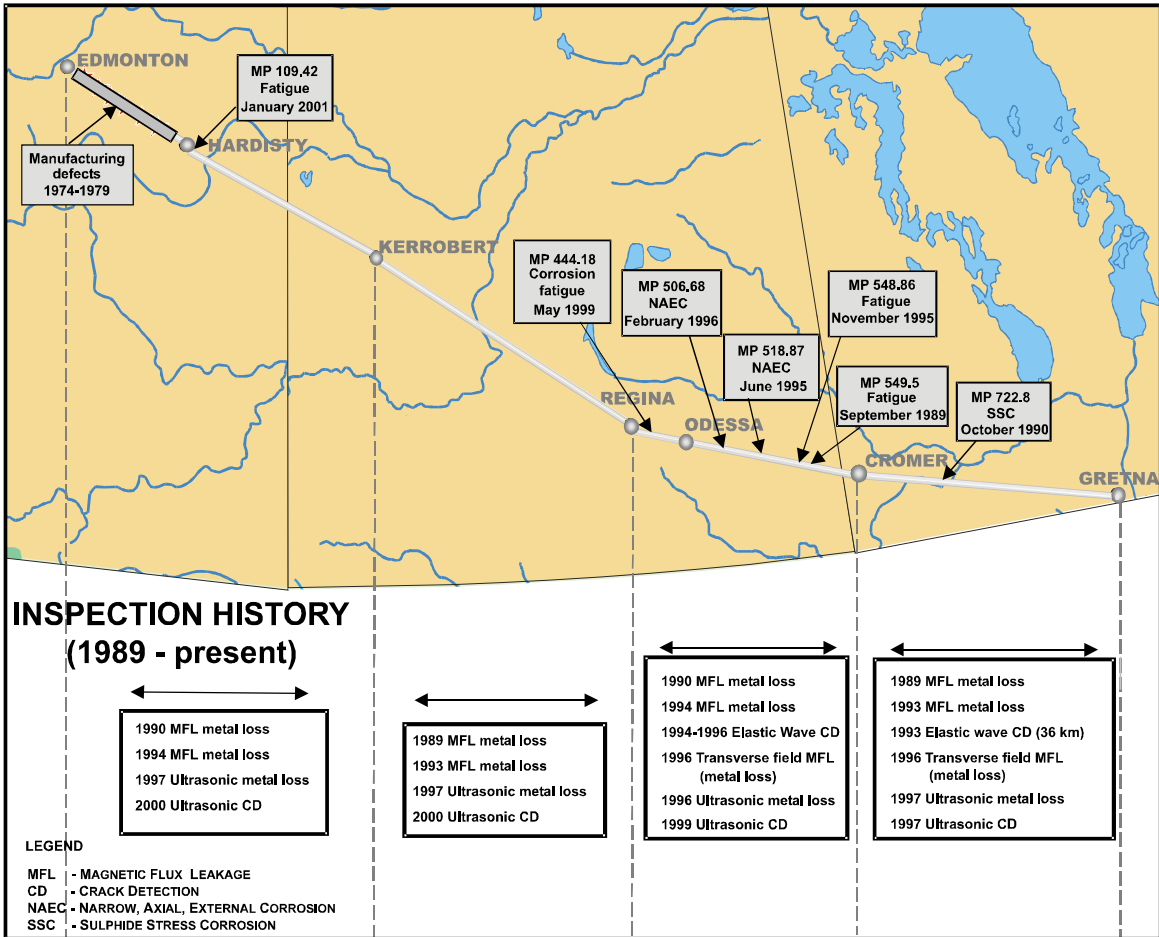
Appendix A – Long Seam Failures on Line 3/4 (864 mm)

The following long seam-related failures have occurred on the 864 mm line during its operating history:

- 1974-1979—5 ruptures between Edmonton and the Strome pump station due to manufacturing defects;
- 01 September 1989—rupture at MP 549.5 due to corrosion fatigue;
- 17 October 1990—leak at MP 722.8 due to sulphide stress cracking;
- 16 June 1995—rupture at MP 518.87 due to narrow, axial, external corrosion (NAEC) under disbonded coating (TSB report No. P95H0023);

- 13 November 1995—rupture at MP 548.86 due to fatigue cracking under disbonded coating (TSB report No. P95H0047);
- 27 February 1996—rupture at MP 506.68 due to NAEC under disbonded coating (TSB report No. P96H0008); and
- 20 May 1999—rupture at MP 444.18 due to corrosion fatigue under disbonded coating (TSB report No. P99H0021).
